# Manhole Inspection Summary

Manhole # S25GG\_023MH

Insp Date: **9/6/07 12:20 PM**

**Location** Address: **2001 PRESSTMAN ST**

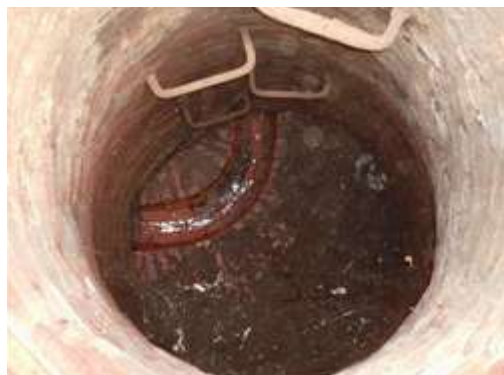
Top View

Corroded steps. Evidence of surcharge -  
Bech debris.

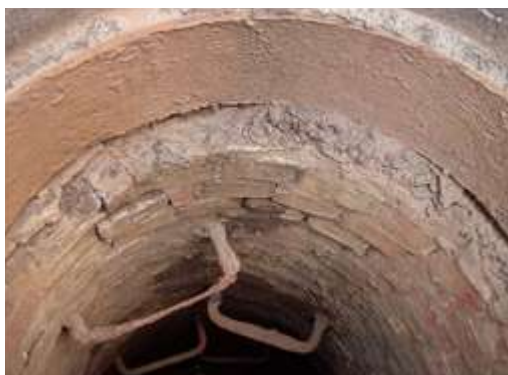
Defect

Frame leaks. Frame offset. Adjustment  
deterioration, loose brick and infiltration.  
Barrel infiltration.

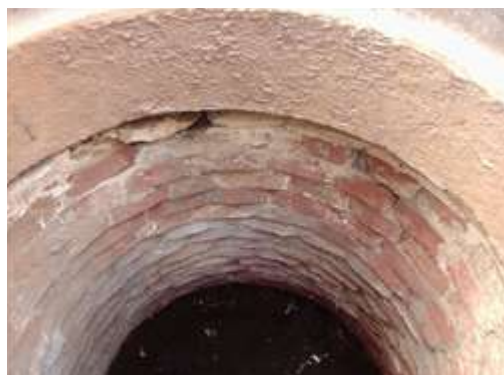
Defect

Frame leaks. Adjustment deterioration  
and infiltration. Barrel infiltration.

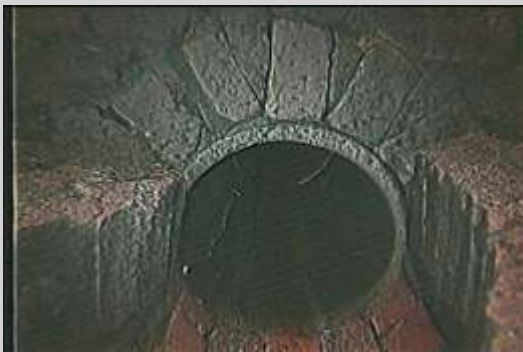
Pipe Out @ 12 O'Clock

Infiltration: **None** Pipe Seal Cond: **Cracked**

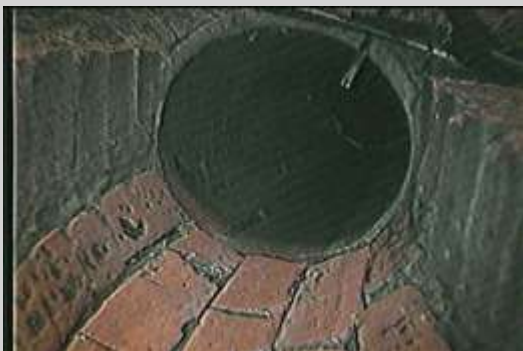
Pipe In @ 9 O'Clock

Channel deterioration.

Infiltration: **None** Pipe Seal Cond: **Cracked**
